Project Report: Canyon Lands Salt Creek Road
Field Review, Analysis, Conclusions, and Recommendations
Henry Shovic, PhD
Rocky Mountain Cooperative Ecosystems Study Unit
May 3, 2009

This document addresses Objective Two in the agreement “to provide alternative development analysis and support” for three project areas as designated by NPS staff. This report focuses on the Canyonlands Salt Creek road.

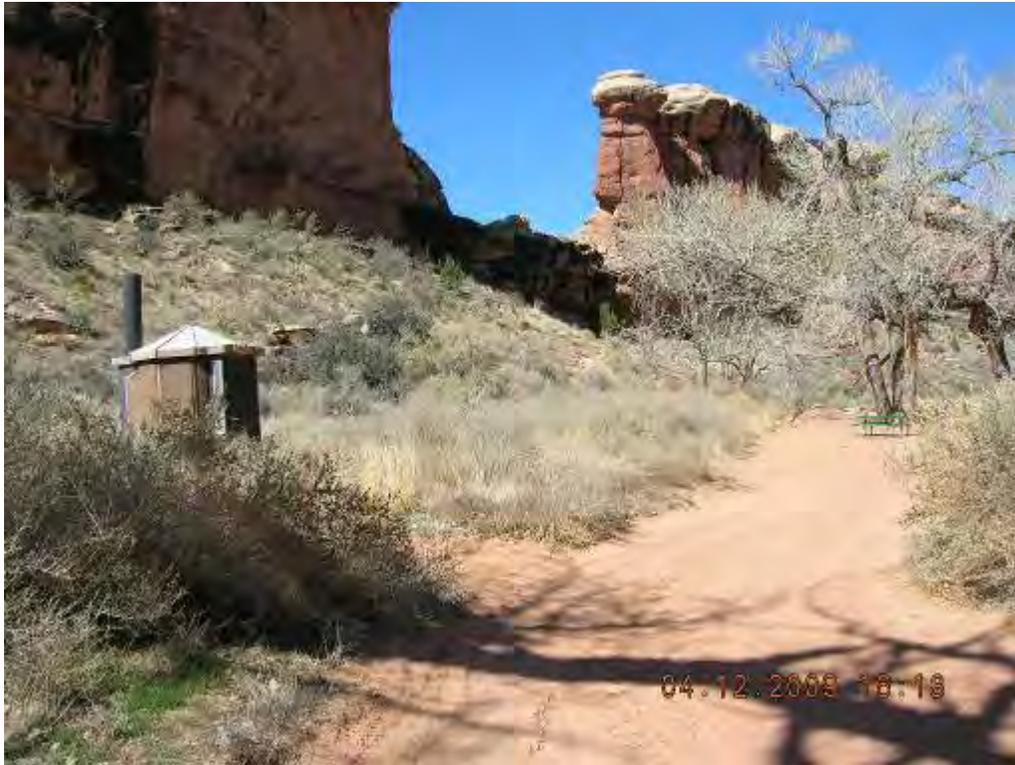
Sandy soils at Peekaboo Campground

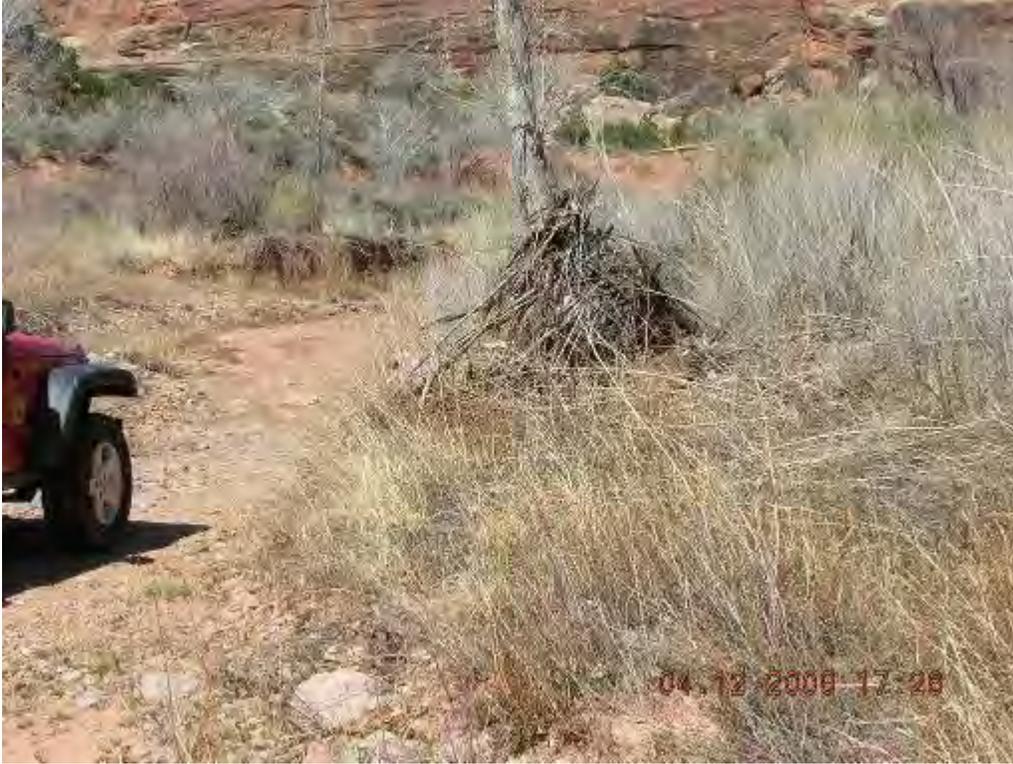
Evidence of flooding below the campground in Salt Creek

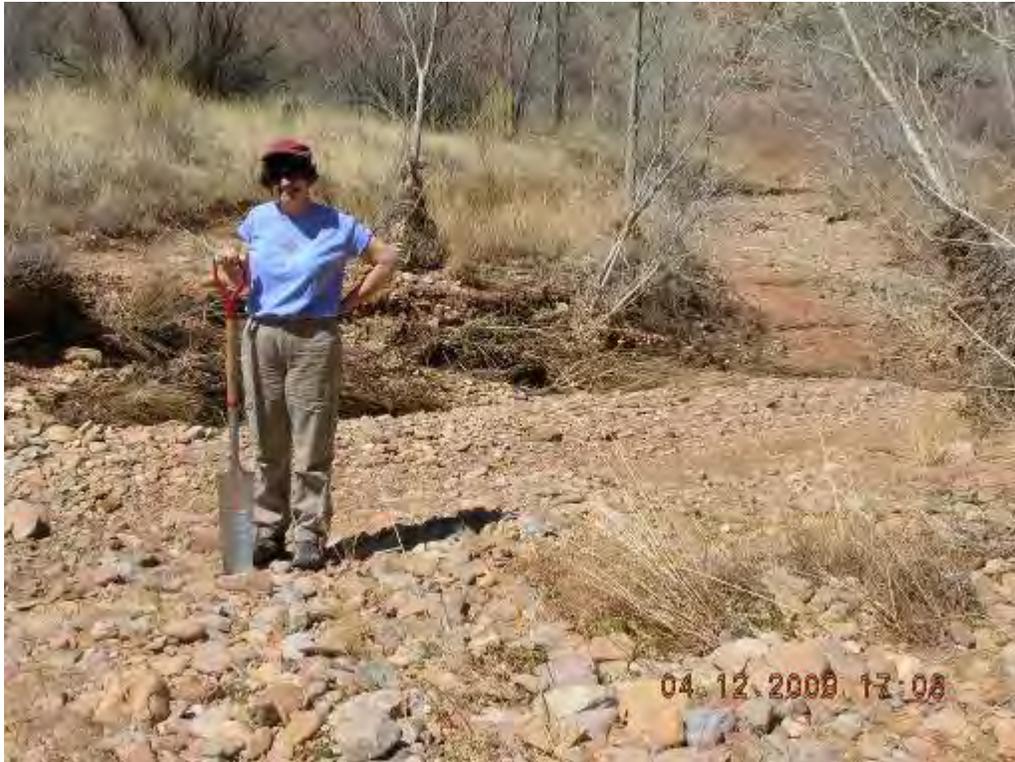
Gravel and cobble stream bed on upper channel

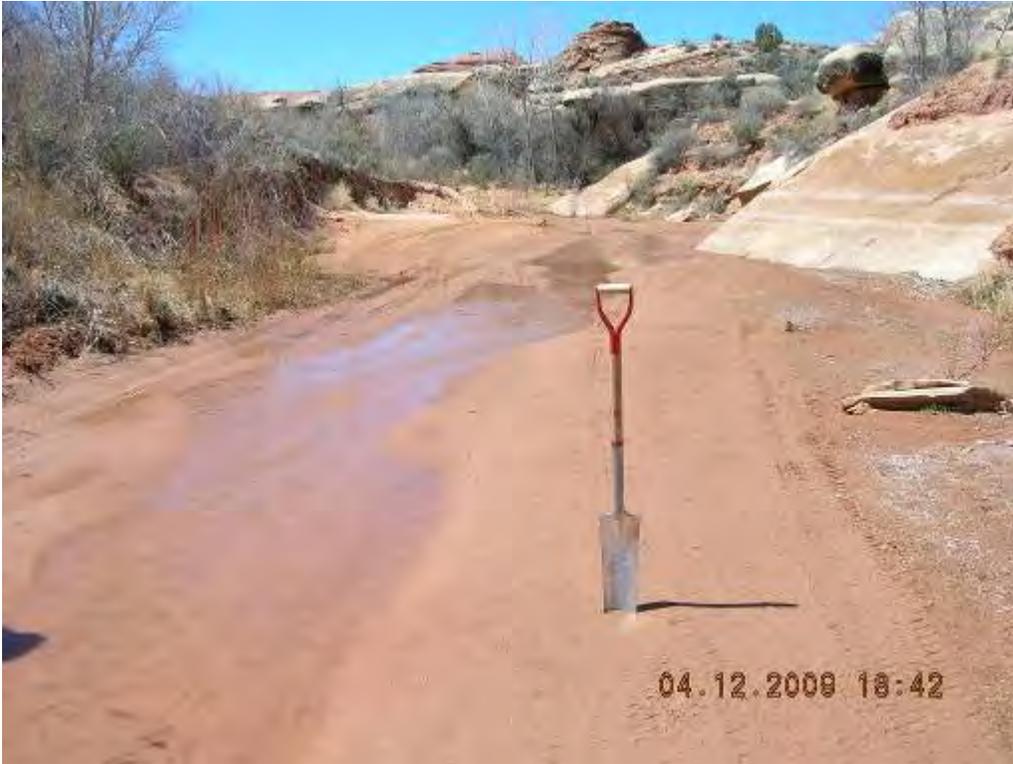
Sandy stream bed midway on lower channel

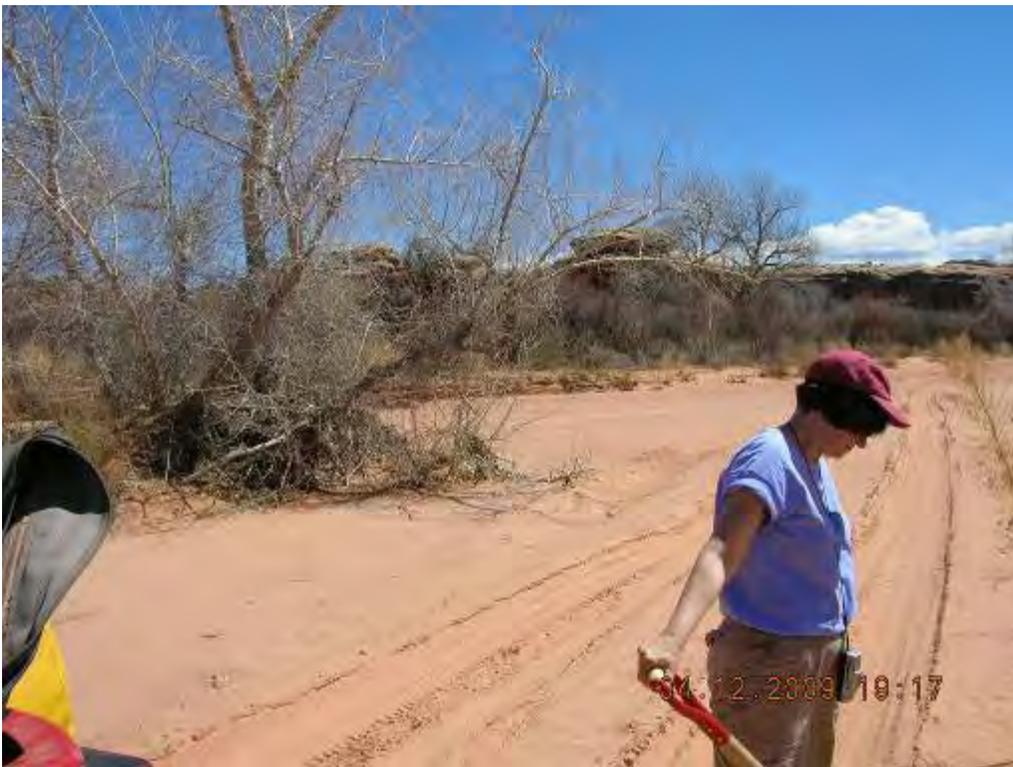
Sandy, poorly-defined stream bed on the lower channel.

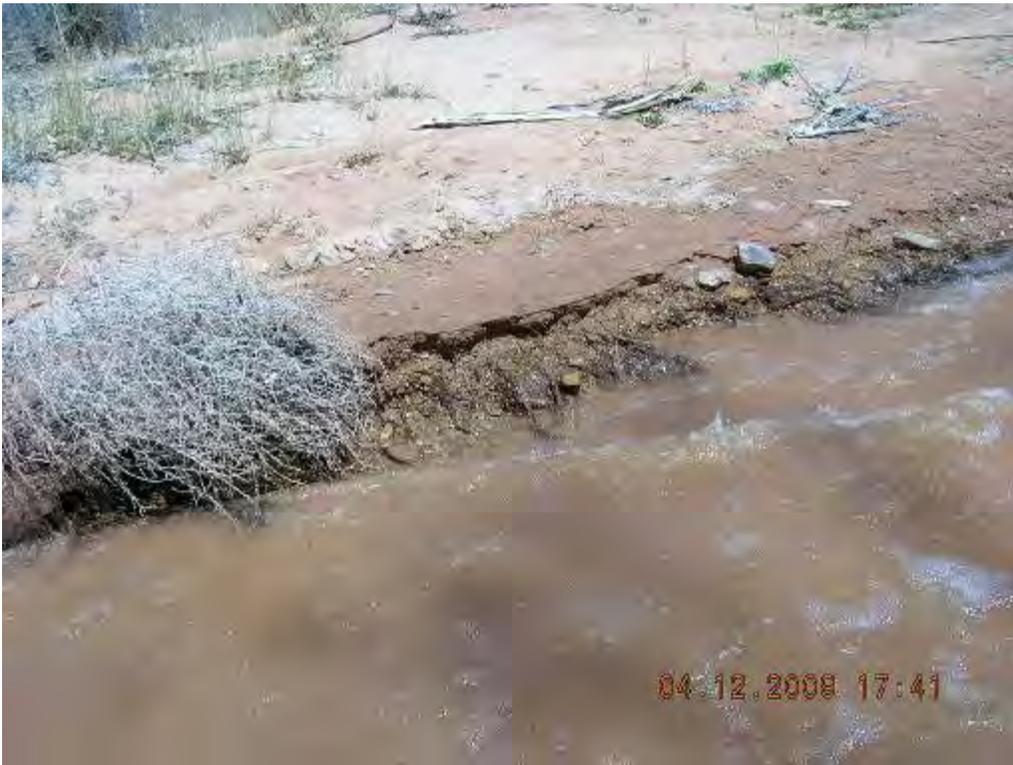
Vehicle impacts appear to be significant in the flowing part of the stream (Point 23 to 57). Disturbance is significant from even a very slow traverse (less than 1 mph), with apparent erosion of side banks, exposure of roots, and turbidity. These are all probably detrimental to bank vegetation and invertebrate health.

Erosion, turbidity, and root exposure from low velocity vehicle traverse

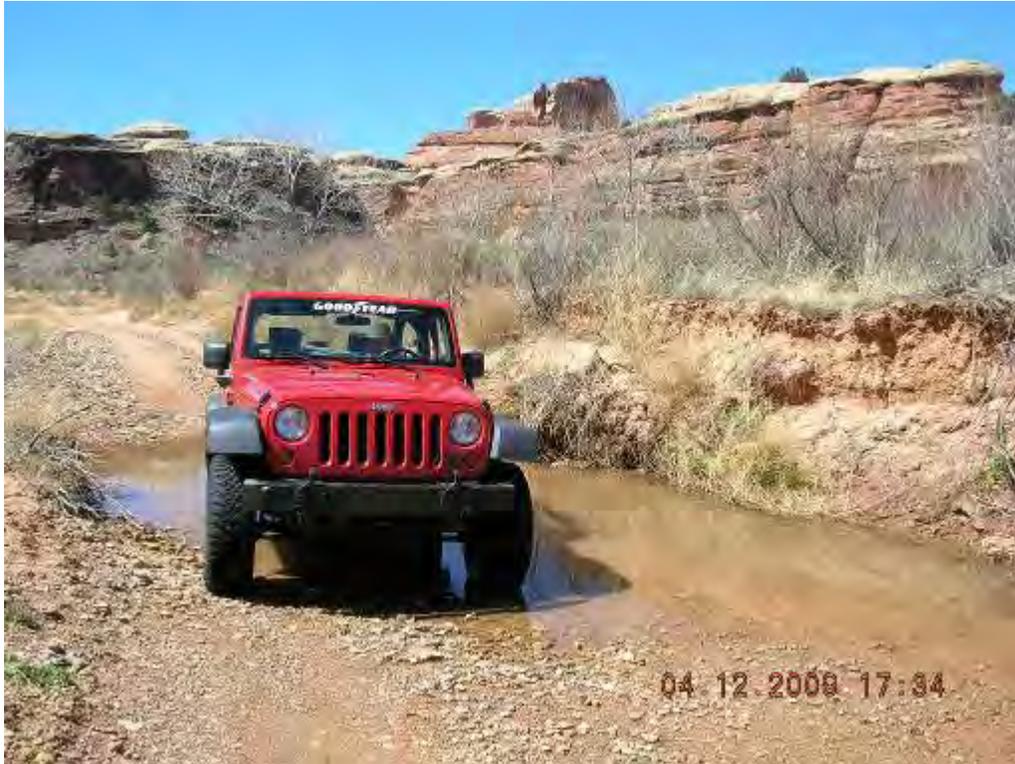
Large holes occur in the active channel. These are apparently related to vehicle use, similar to the formation of potholes or washboards on other native surface roads. These holes can be large enough to affect stream flow (Point 40).

Pothole probably caused by repeated vehicle traverse

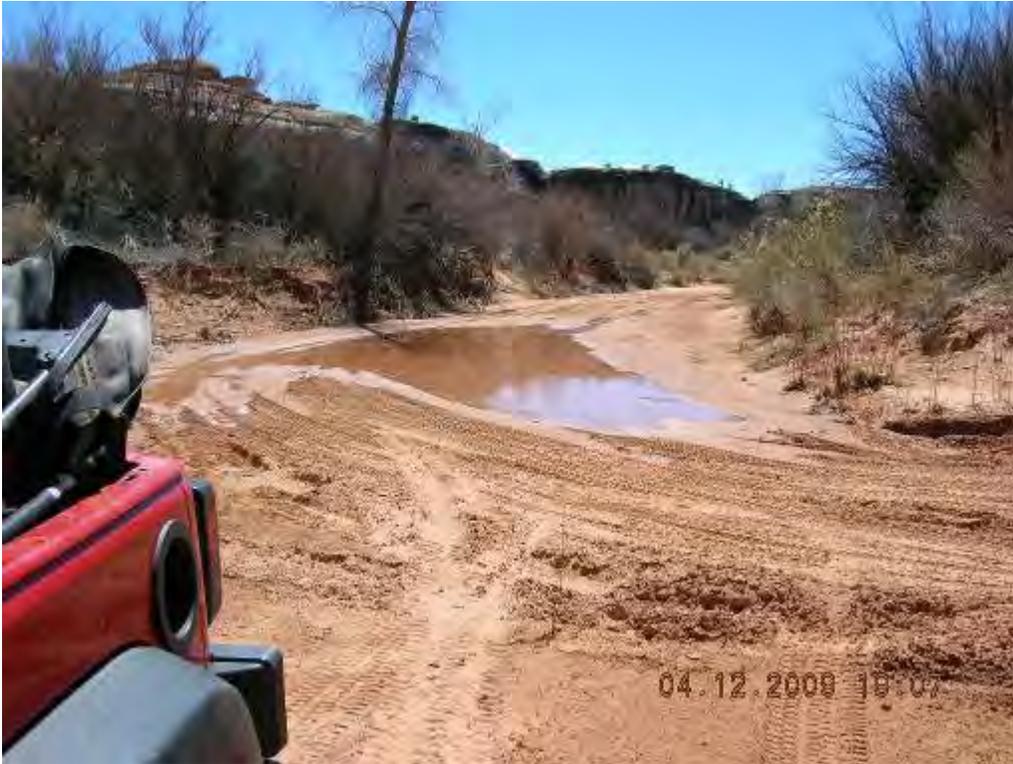
Stream character with vehicle use

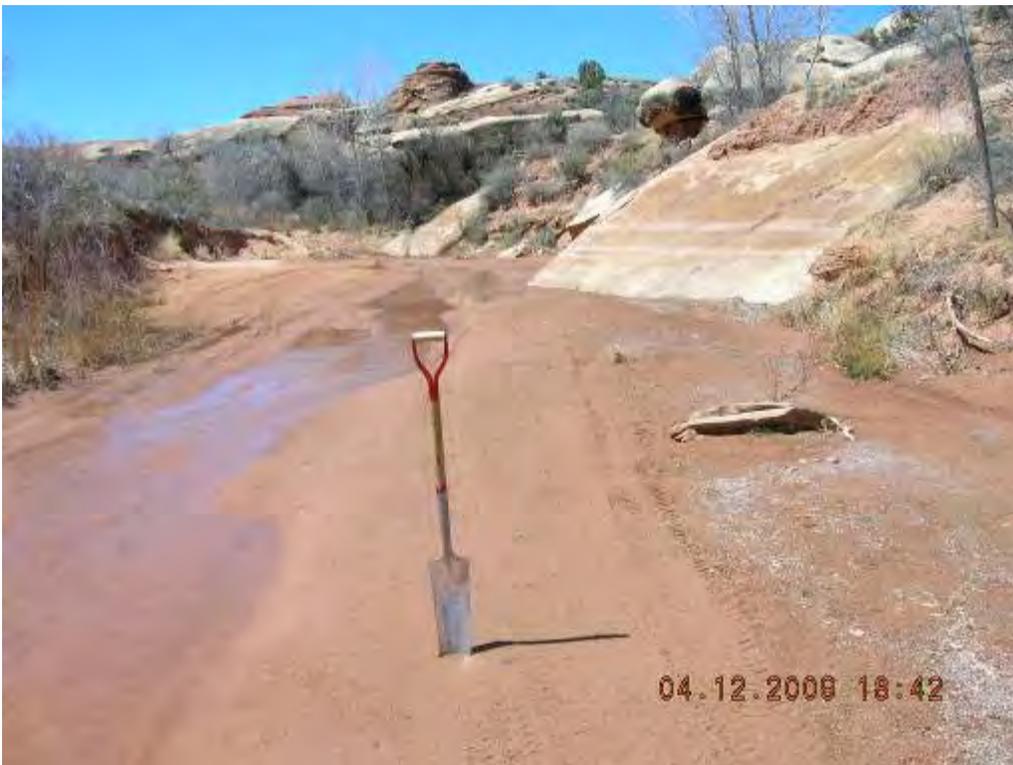
Stream character with vehicle use (bathtub ring area)

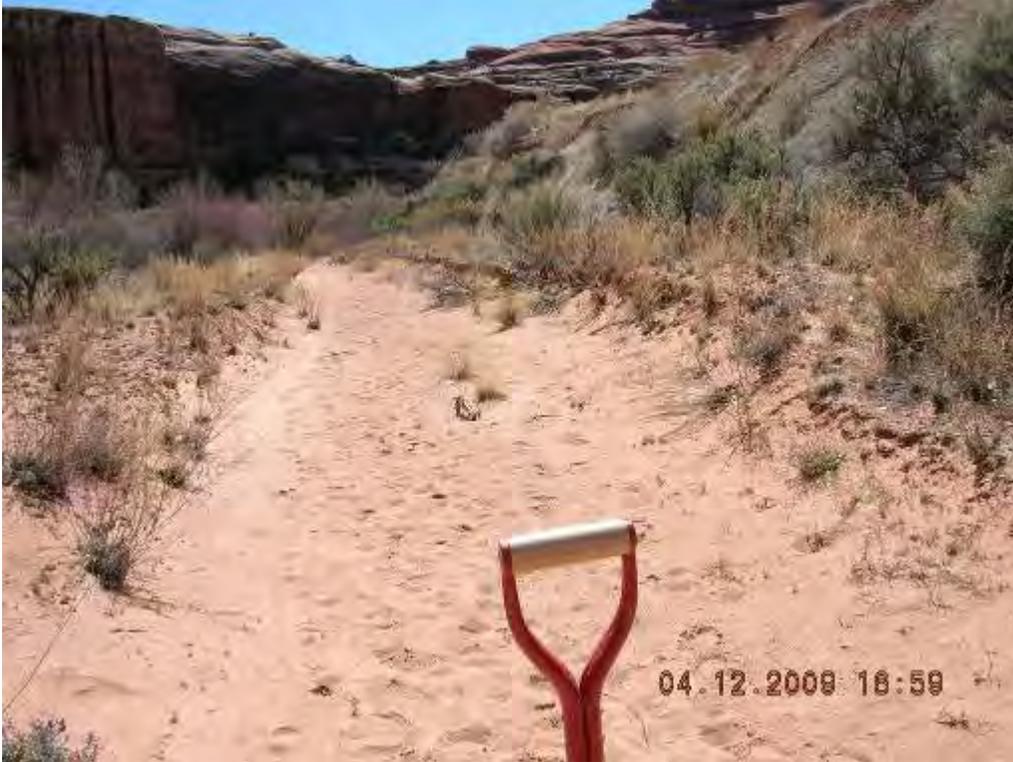
Removing vehicle traffic from channels or roads was observed to be enough to initiate vegetative recovery. At Point 20, past the gate closure, cut banks are sloughing towards a stable slope. At Point 21, an unused road has vegetation and incipient biological soil crust.

Natural sloughing and filling of unused road

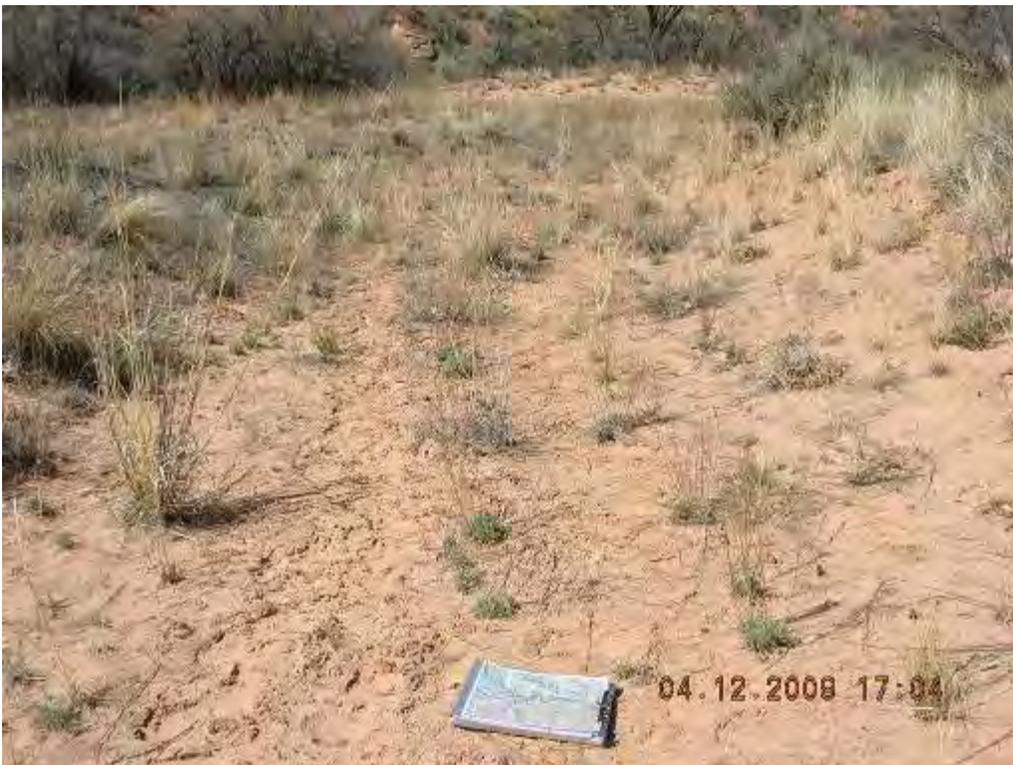
Natural revegetation and biologic soil crust formation on unused road

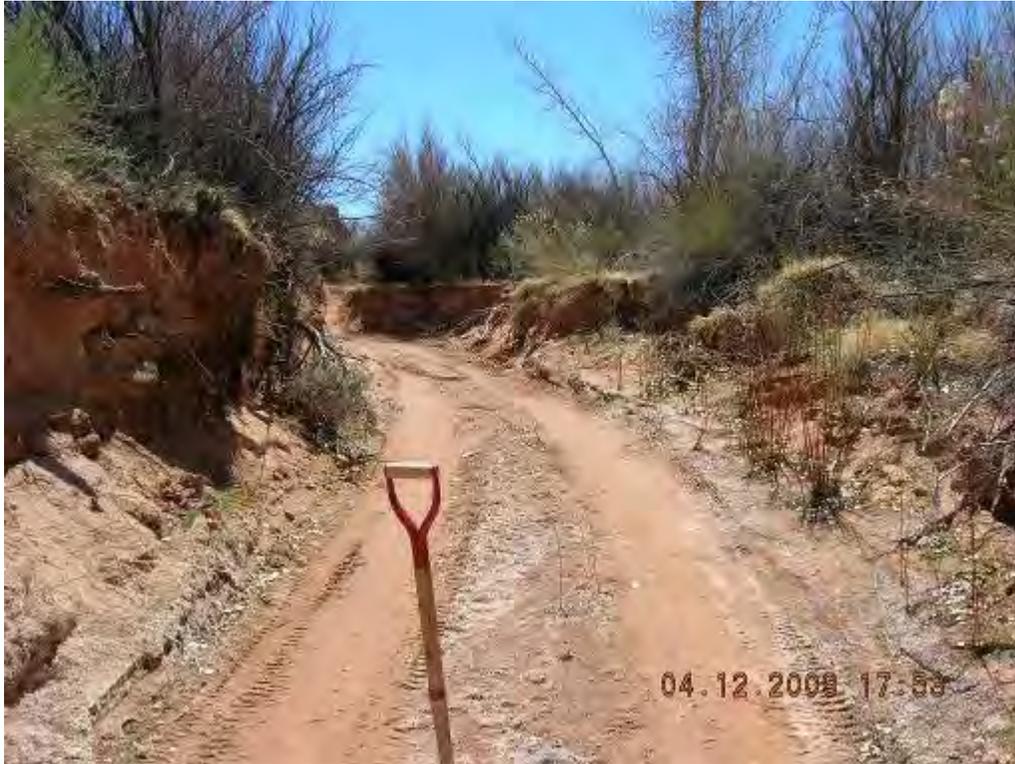
Horse Canyon road transects a series of steep banks (Point 44 to 46) in extremely sandy material. It has been eroded by vehicles and by intermittent stream flow down the road. Where slopes are gentle, little erosion has occurred.

Erosion on Horse Canyon road on steep sections

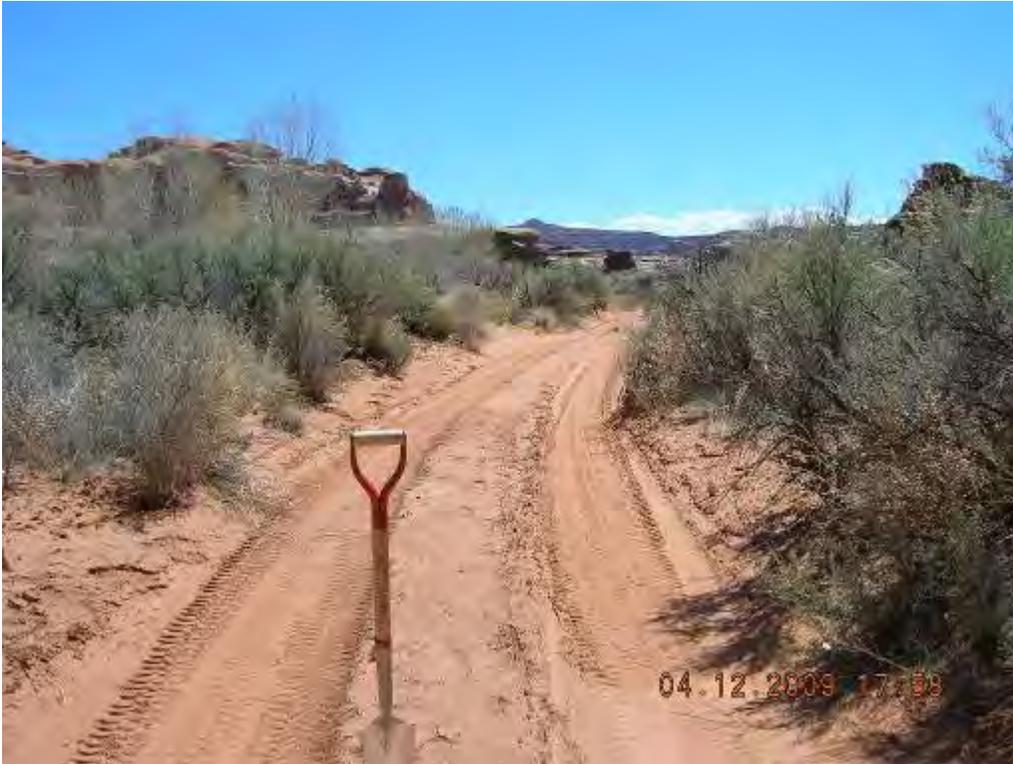
Erosion on Horse Canyon road on gently-sloping area

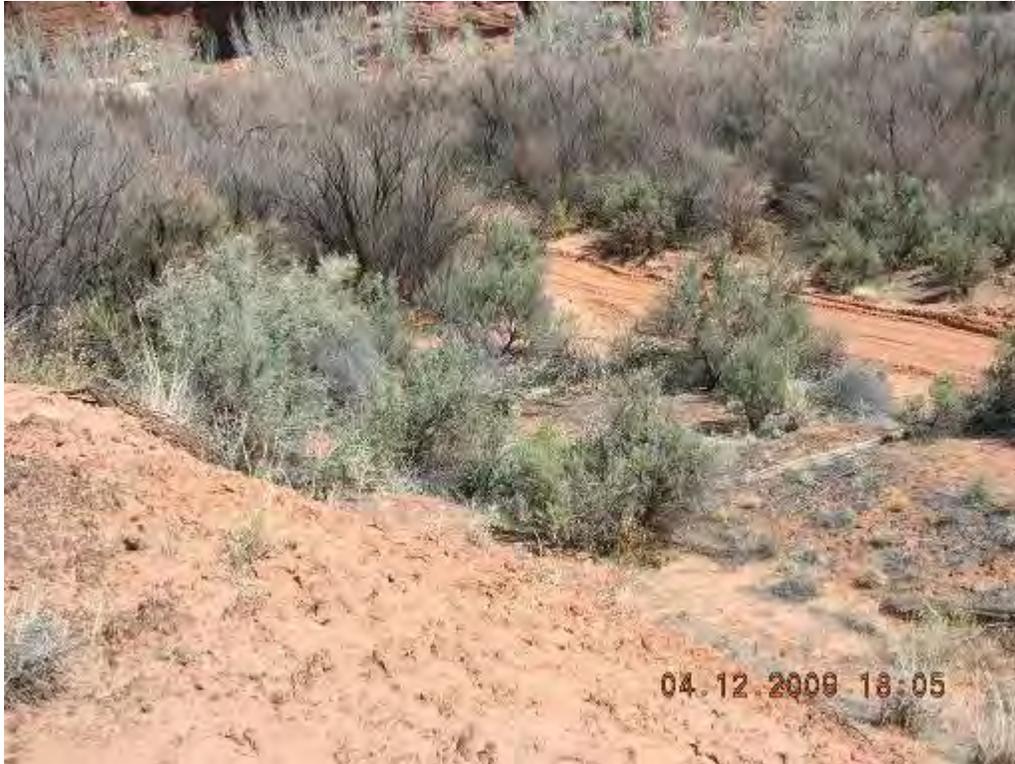
Two potential reroutes have been identified (blue and dashed red in Figure 3). Each appears to have potential to avoid the current road location, but both come very close to an observed cliff line, which probably extends south past the symbolized location on Figure 3, based on the aerial imagery. Both also appear to traverse steep sandy bluffs (slopes $> 30\%$).

Overview showing steep, sandy bluff and Horse Canyon road below

Therefore, both bedrock and steep, erosive slopes are likely to be potential problems for any road re-route through this area. Though it appears feasible, it will probably require engineering analysis and road mitigation measures such as surfacing, drainage structures, and grade control.
