Project Report: Canyon Lands Salt Creek Road
Field Review, Analysis, Conclusions, and Recommendations
Henry Shovic, PhD
Rocky Mountain Cooperative Ecosystems Study Unit
May 3, 2009

This document addresses Objective Two in the agreement “to provide alternative development analysis and support” for three project areas as designated by NPS staff. This report focuses on the Canyonlands Salt Creek road.

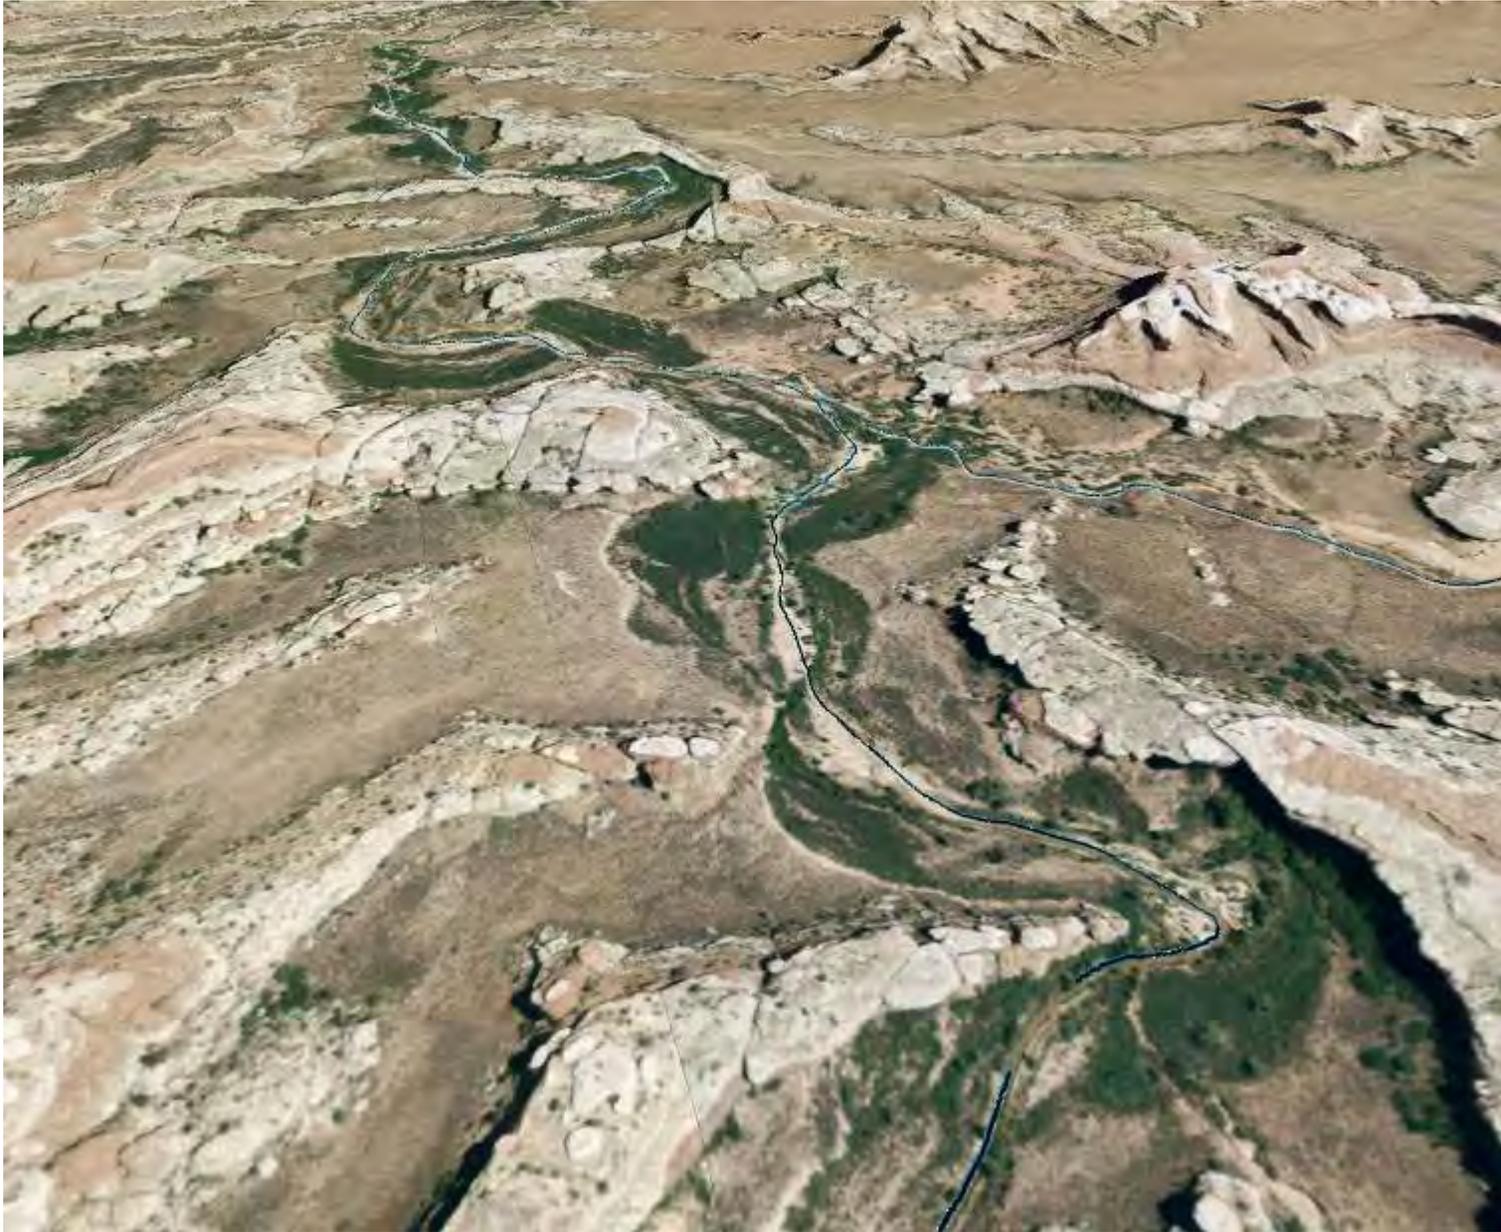
Figure 1 shows the landscapes of the Salt Creek valley (looking from South to North). Slopes are gentle to steep, with the main road following a following a vegetated stream course and associated flood plain. Uplands are derived from the Cedar Mesa Sandstone with very sandy regolith, and most of the lowland is composed of very sandy alluvium and wind-deposited sand with some river gravels. The road itself is about 3 miles long. About 80% is in the active stream channel of Salt Creek. Flooding is apparently common and significant.

Figure 1. Landscapes of the Salt Creek Road Area, looking from south to north.

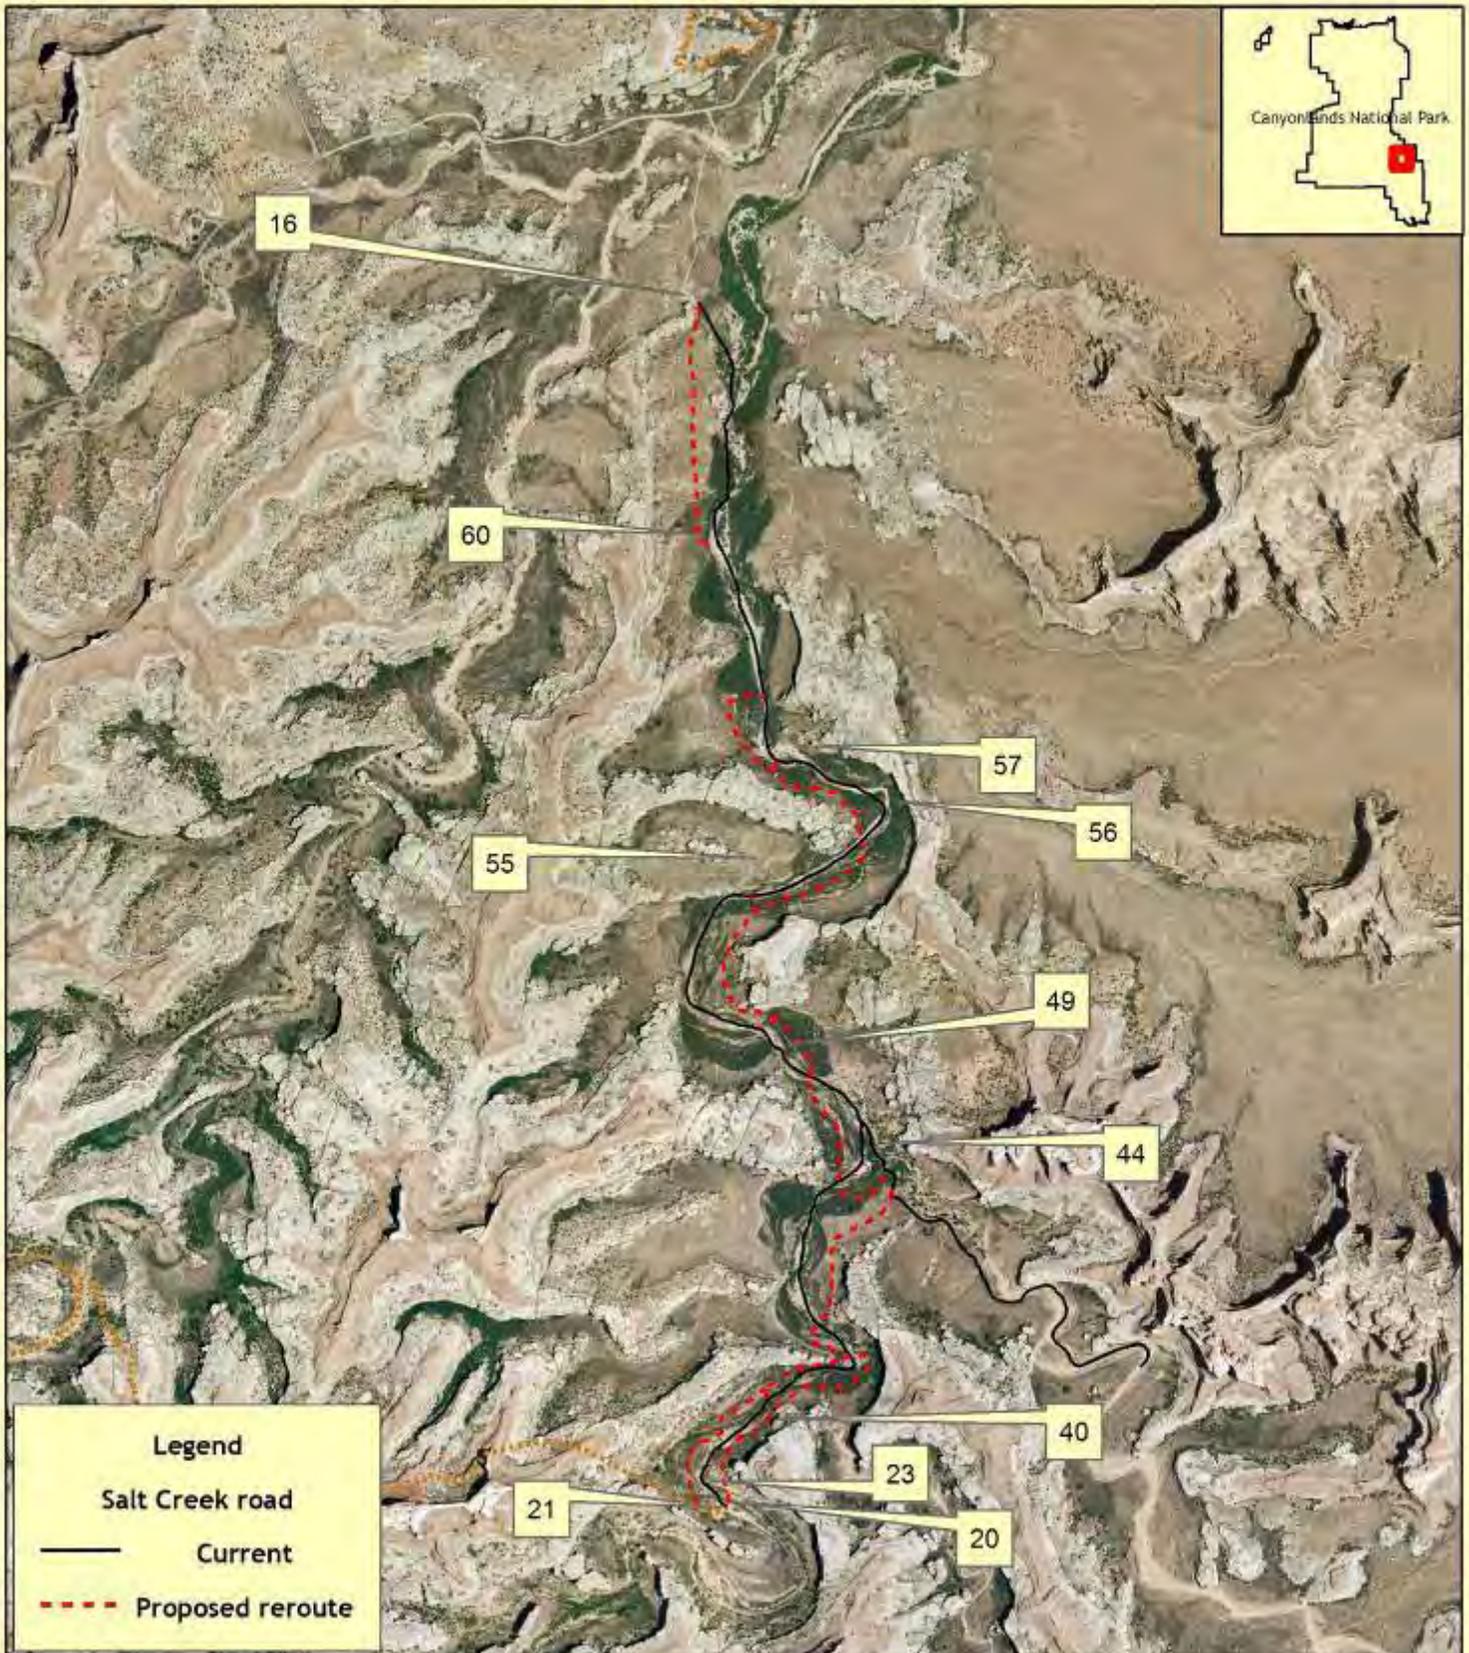
Canyonlands National Park: Salt Creek Road Review

Figure 2 shows the project area and salient review analysis by location. It is based on the data in Appendix One. See the following discussion for each marked point or area.

The current road follows the active stream channel in the Floodway for 80% of the project area from the gate (Point 16) to the closed gate near Peekaboo Campground (Point 20) (Figure 2). A proposed re-route of the road is shown in Figure 2 (red dashed line). The re-route follows terraces surrounding the current road, with at least four intersections with the stream channel/current road.

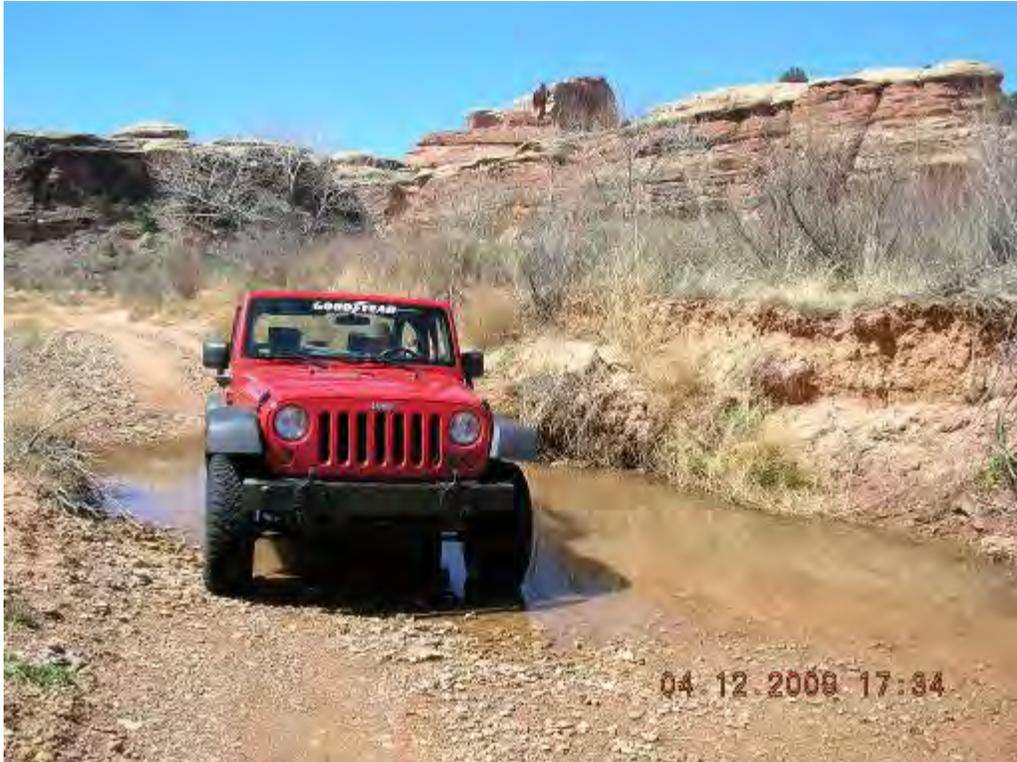
- The Floodway (including the active channel) has no vegetation and probably flows every year.

Floodway

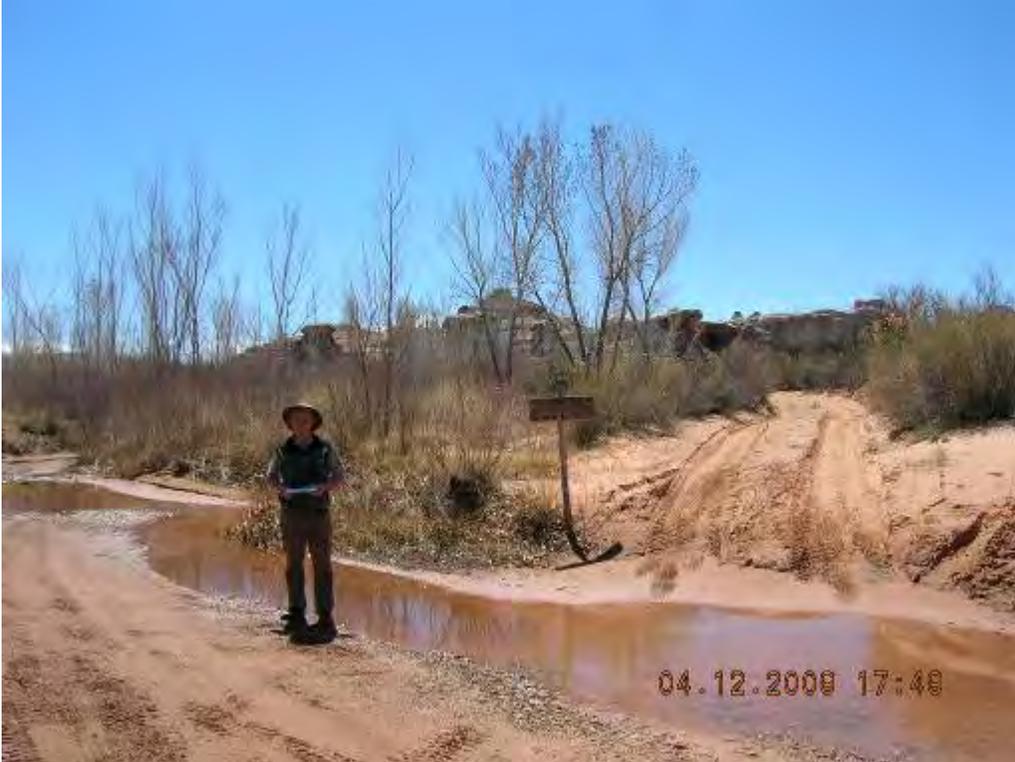
- The Low Terrace (represented by Point 49) is about five feet above the Floodway. This terrace shows evidence of occasional flooding and has a very sandy substrate.

Low Terrace

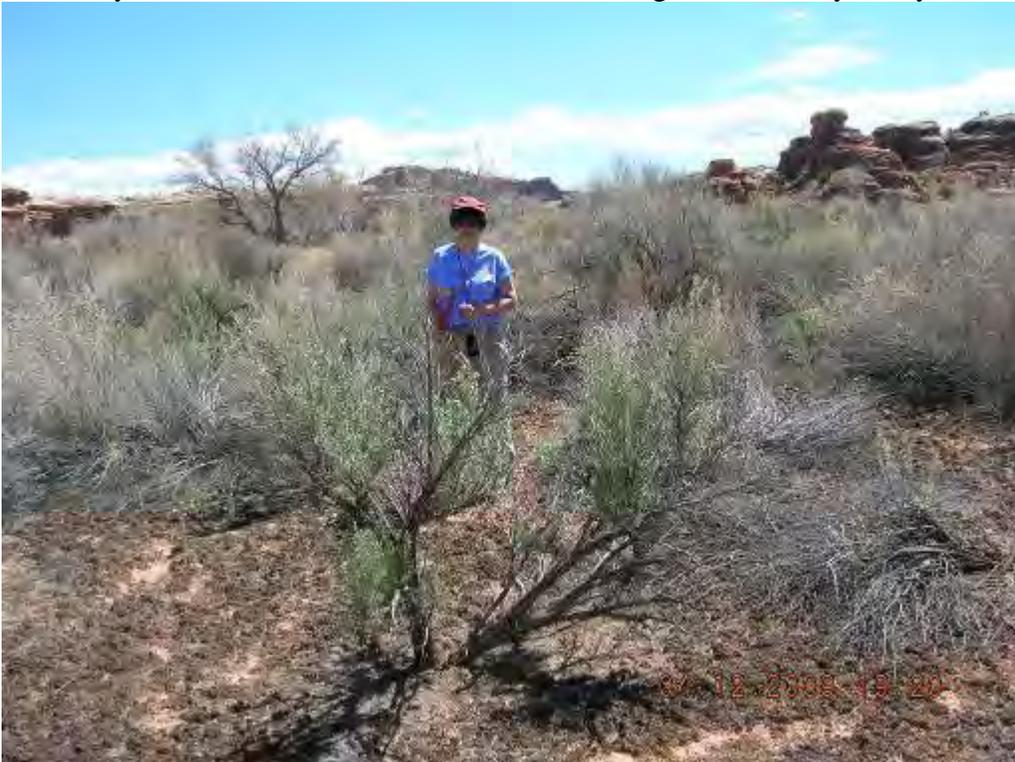
- The High Terrace (represented by Point 55 and 60) is about eight to thirty feet above the Floodway and shows no evidence of recent flooding. It has a very sandy substrate.

High Terrace

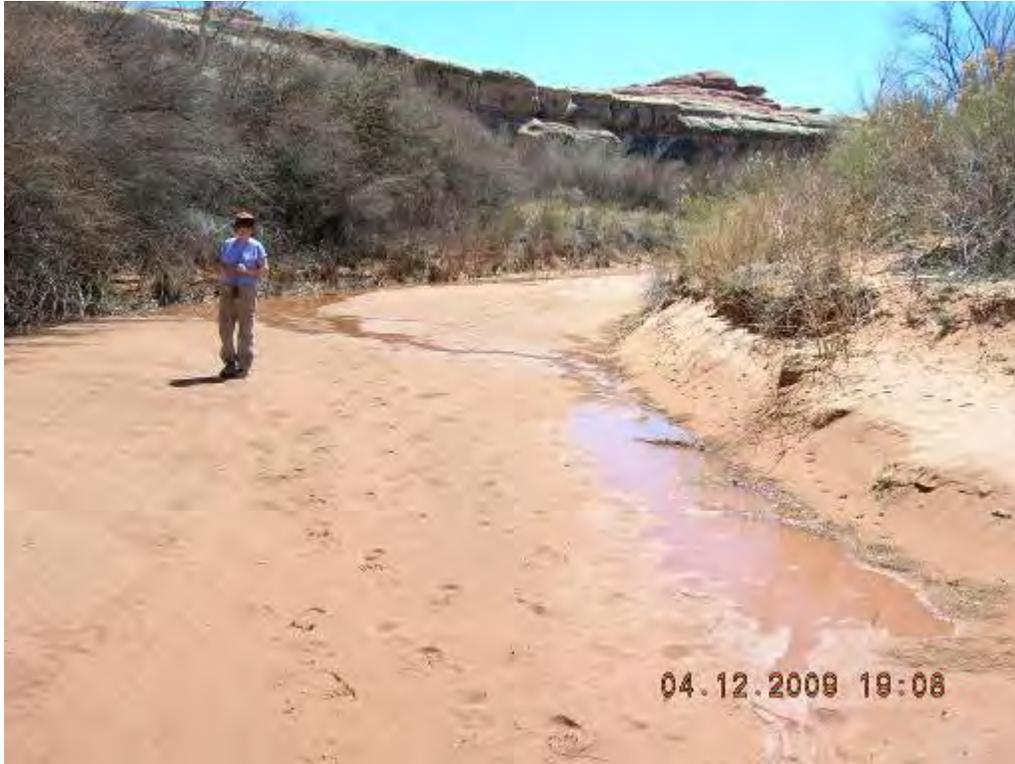
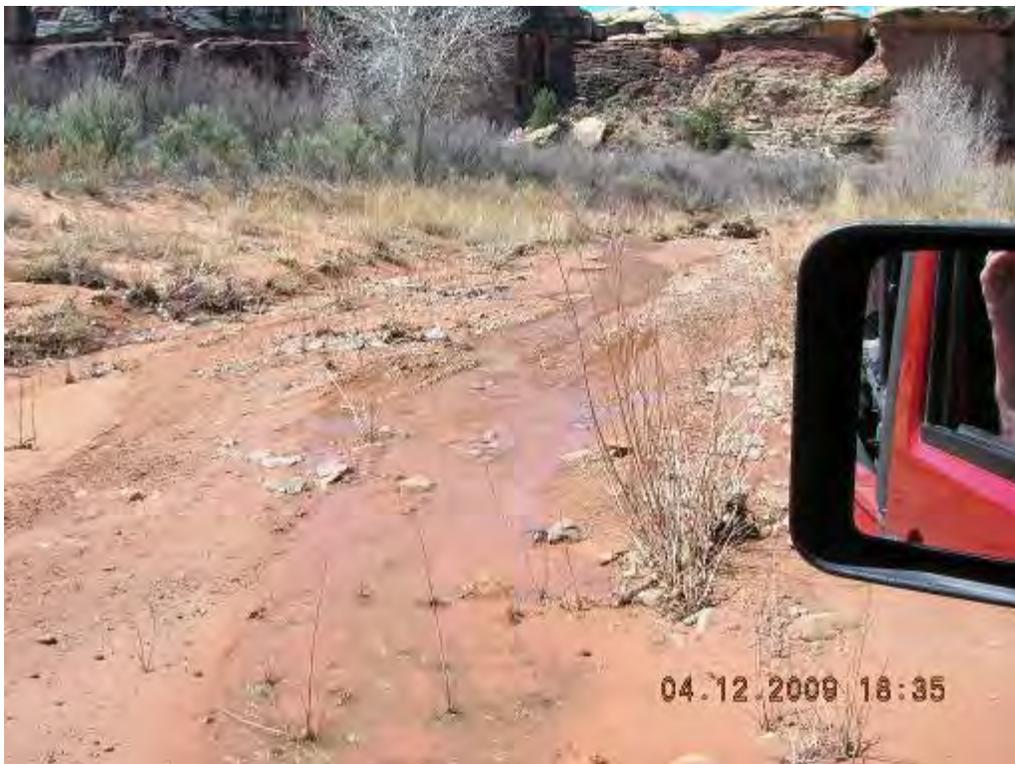
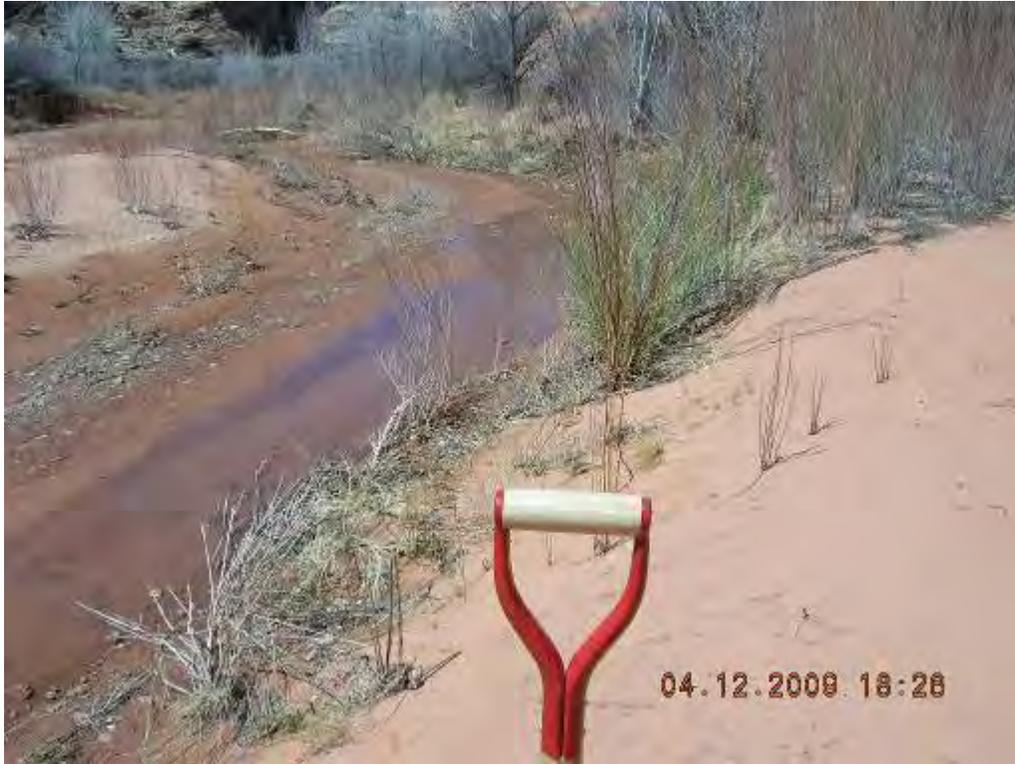
Stream channel characteristics appear to be different in areas without the impacts of vehicle traffic. At Point 56, a segment of stream channel shows no evidence of vehicle use. The channel is significantly different than the nearby road/channel. No large holes or unconnected pools occur in the un-driven area. In nearby stream channels with no apparent vehicle use, vegetation is present in the channel and it is less disrupted by large holes.

Stream character without vehicle use

Stream character and vegetation without vehicle use

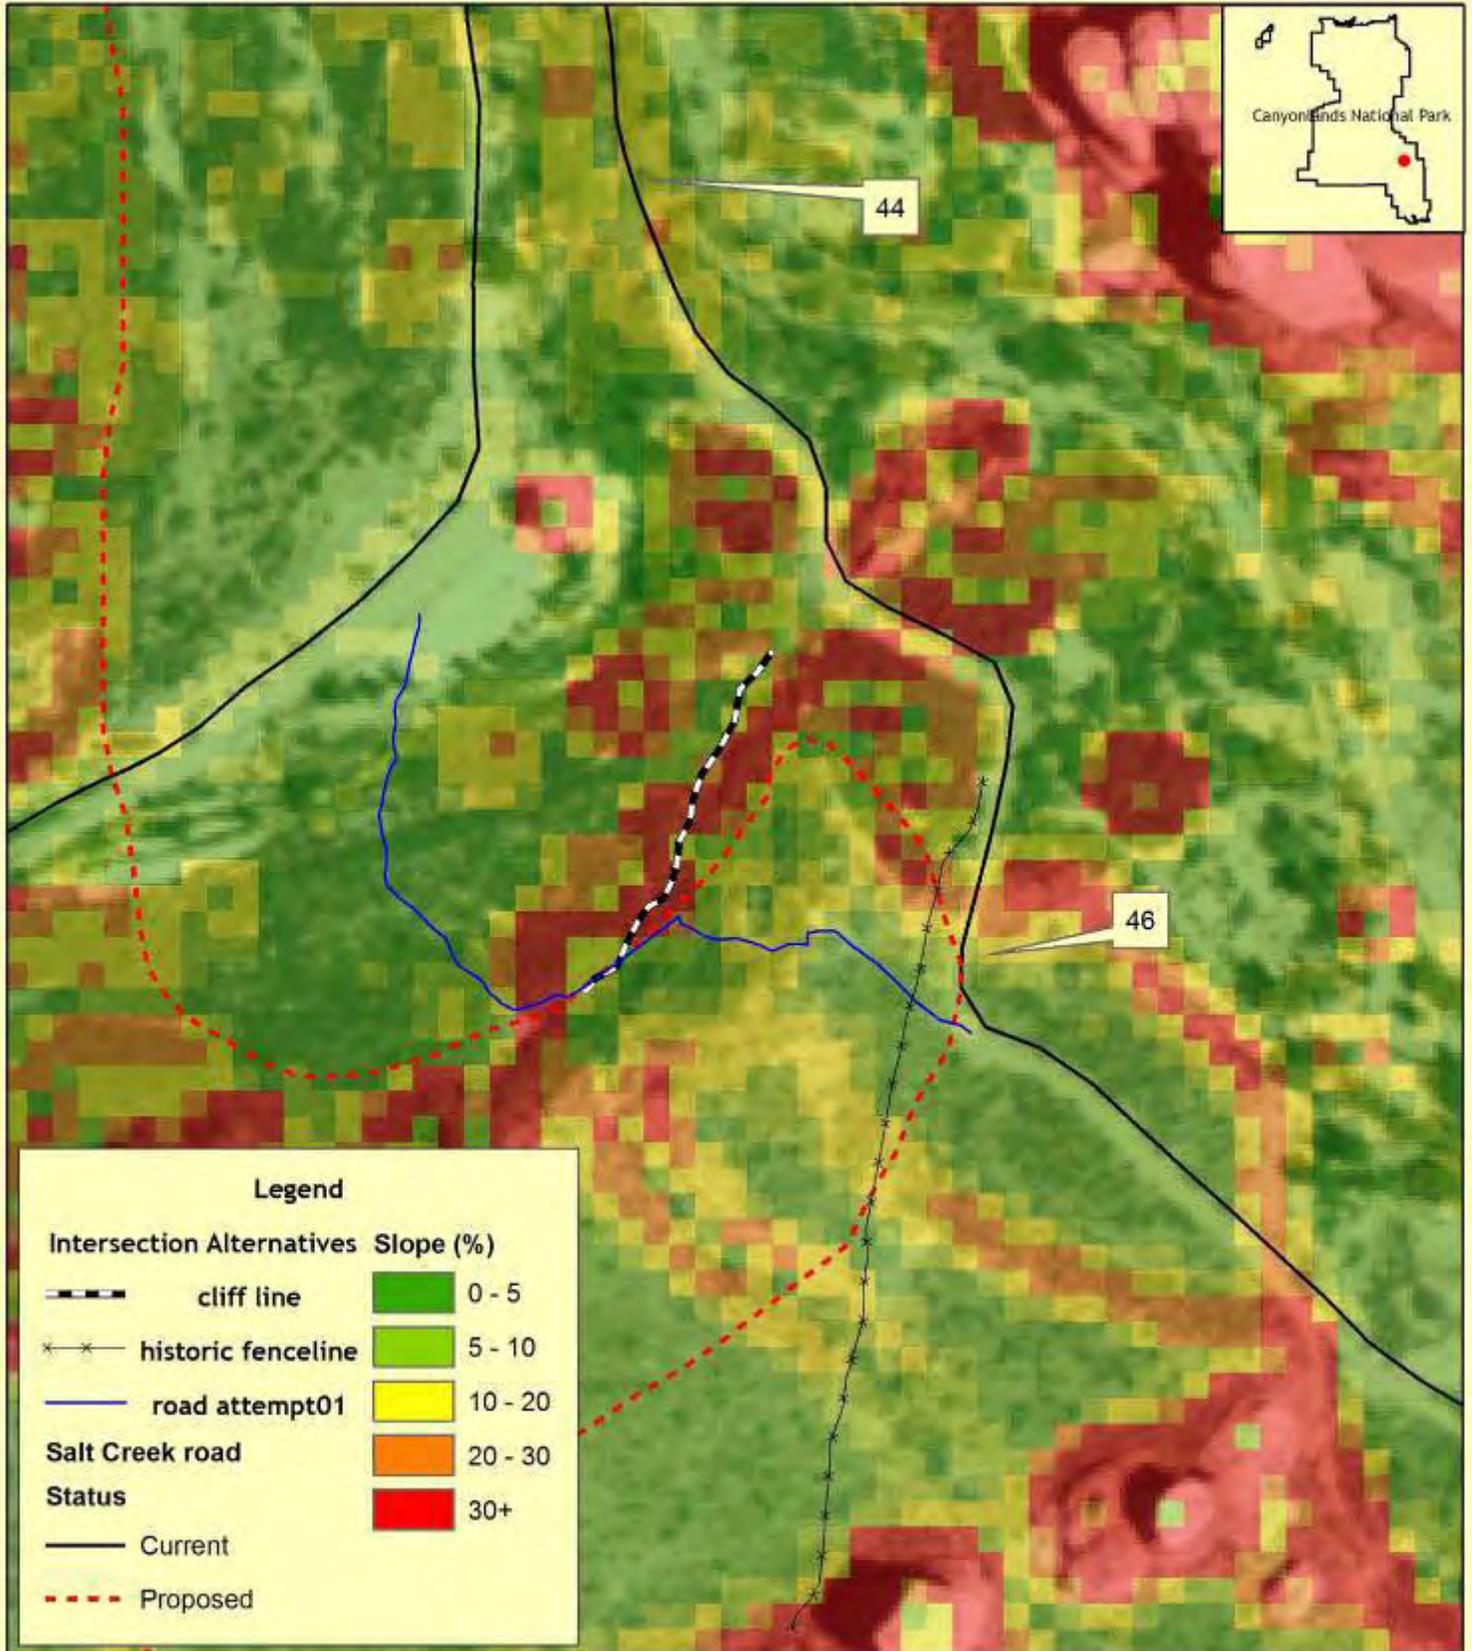
Canyonlands National Park: Salt Creek Road Review

A particular potential problem area was identified on the Horse Canyon road (Point 44 on Figure 2).

Two potential reroutes have been identified (blue and dashed red in Figure 3). Each appears to have potential to avoid the current road location, but both come very close to an observed cliff line, which probably extends south past the symbolized location on Figure 3, based on the aerial imagery. Both also appear to traverse steep sandy bluffs (slopes $> 30\%$).
